RE: Mission Field Airport – Compliance Safety Inspection

Mission Field Airport (LVM)

Compliance Inspection Report

Inspection Date: August 28, 2014

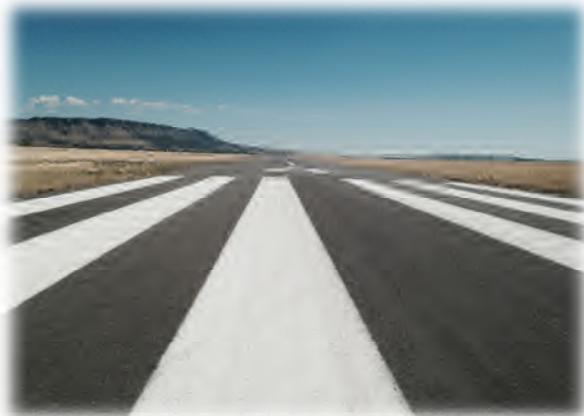
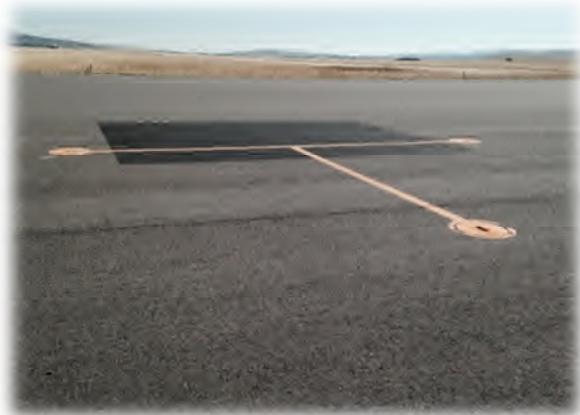
The Mission Field Airport pavements were observed to be in very good condition. The FY-2011 rehabilitation projects are performing very well. It is not anticipated that efforts beyond normal pavement maintenance will be required within the next 5 years.

The Sponsor should anticipate initial cracking (expansion and contraction) and surface oxidation within the next 2 to 4 years. The Sponsor's Capital Improvement Plan (CIP) currently projects rehabilitation efforts in FY-2016. This appears to be a reasonable assumption and the Airport's maintenance needs can be further evaluated as that timeframe approaches.

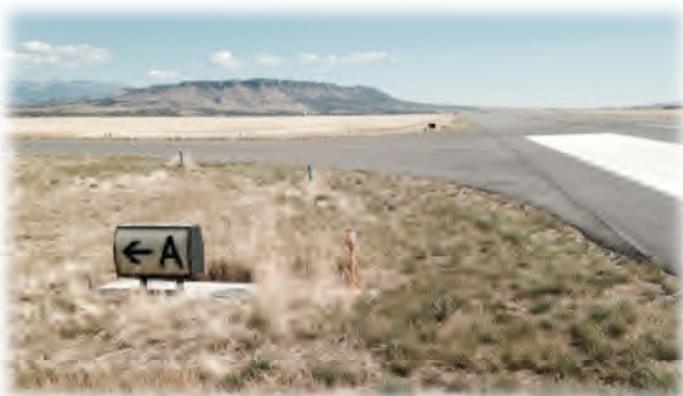
The airport has done an excellent job of maintaining the vegetation heights and grading within the safety areas. It was also observed that grading around sign and light foundations have been adequately maintained. The Sponsor is encouraged to continue their inspection and remediation efforts to ensure no safety area mounds, depressions, or exposed edges in excess of 3 inches develop.

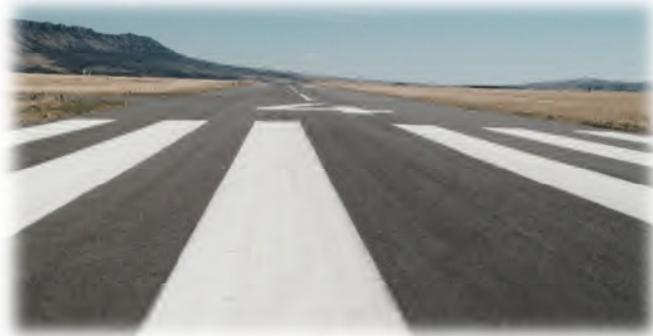
The surface markings are performing very well and serving their intended function. The airport will need to continue monitoring these features as they continue to age and perform maintenance as needed.
