Bridge Inspection Reports

STRUCTURE INSPECTION REPORT

Structure # 03808
 FLATHEAD CREEK 009 - NE WILLSALL

Bridge Inspection Date: 07/24/2018

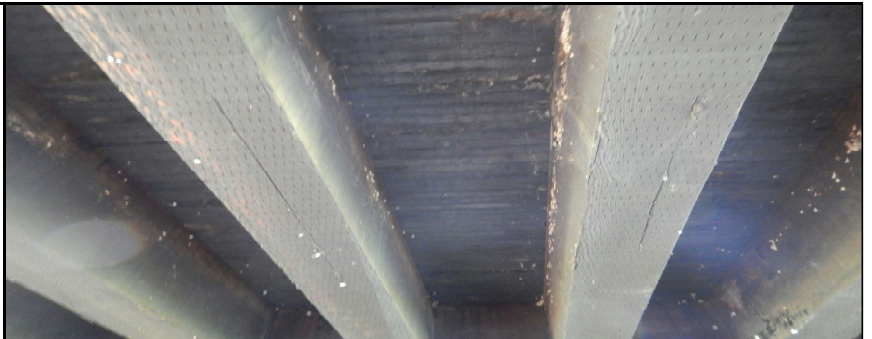
Element:111 - Timber Open Girder|Beam (LF)

CS2 checks:
 Span 1: G1 - full length (26 ft), G2 - full length, G4 - 6 ft, G5 and 6 - 6 ft on lower surface, G7 - 10 ft, G9 - 3 ft, G13 - 9 ft (86 ft)
 Span 2: G1 - 3 ft, G2 - 4 ft, G4 - full length, G5 - 12 ft(2 ft in lower surface), G7 -8 ft, G8 - wide full length, G10 - full length, G13 - full length (131 ft)
 CS3 checking from previous inspection was not observed

Comments: Typical also of Span 2 G4, G5

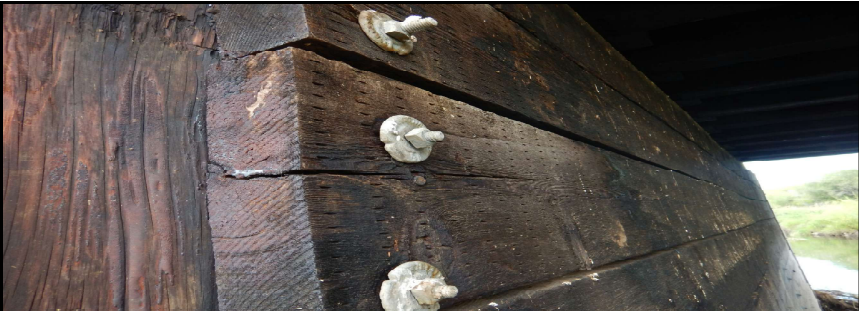
<p>Photo #:CS3 Checking - Near Face- Plank 3</p> <p>Location:</p> <p>Comments:</p> <p>Element:212 - Timber Pier Wall (LF)</p>	 
---	---

5% minor st2 length long checking. Condition State 2 : 5

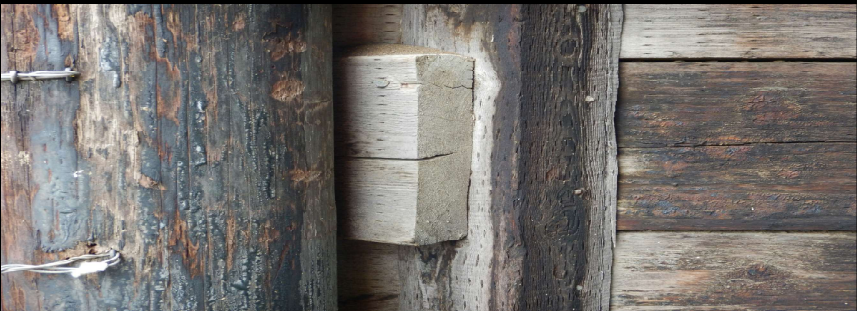
<p>Photo #: Typical End Splits</p> <p>Location:</p> <p>Comments:</p> <p>Element: 216 - Timber Abutment (LF)</p>	 
---	--

Minor scour along Abut 3 backwall and RT wingwall
 Exposure of roadway fill under backwall and erosion around wingwall. See photos in Element 900
 Multiple CS2 checks in all 4 wingwall pile.
 Random areas of CS2 checking in backwalls, wingwalls CS checks most of length
 Many end splits in backwall and wingwall planks - approx 8 ft
 Percent adjusted for defect overlap

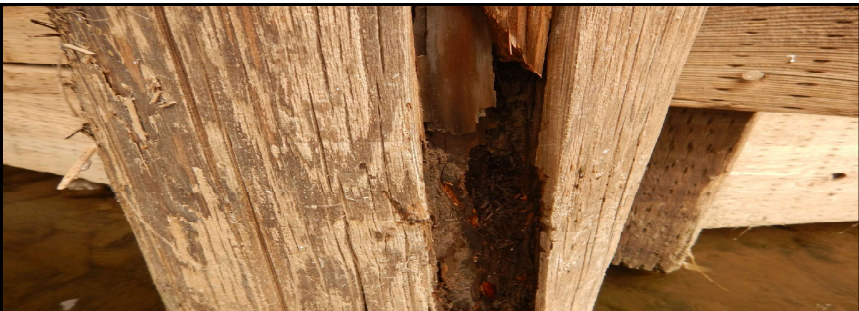
Photo #: Abut 3 - P6 CS3 Check Location: Comments: Element: 228 - Timber Pile (EA)	 
---	--

CS2 checks: Pier 2 - P6 multiple CS2 checks; Abut 3 - P2, P3, P5 multiple CS2 checks
 Abut 1: P1 - wide full length CS3 check, P4 - 5 ft spiral check
 Abut 2: P1 - wide CS3 check, P4 - CS3 check, P6- wide CS3 check in top 4 ft - nearly a split
 Decay in lower 3 ft of Abut 3 - P6. Photos

Repair Suggestions:					
Repair ID	Date Requested	Type	Status	Priority	Comments
#Error	07-25-2018	Repair suggestion	Open	Low	Bank erosion at Abut 3 RT wingwall. Repair is suggested to preserve abutment in future high water events

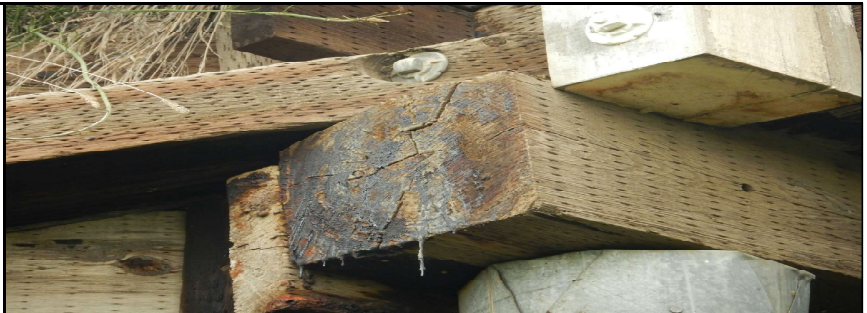
Photo #:Abut 1 Cap End Check

3ft deep of st3 checks on all 6 ends of timber caps. Condition State 3 : 24
 Good condition. Condition State 1 : 76

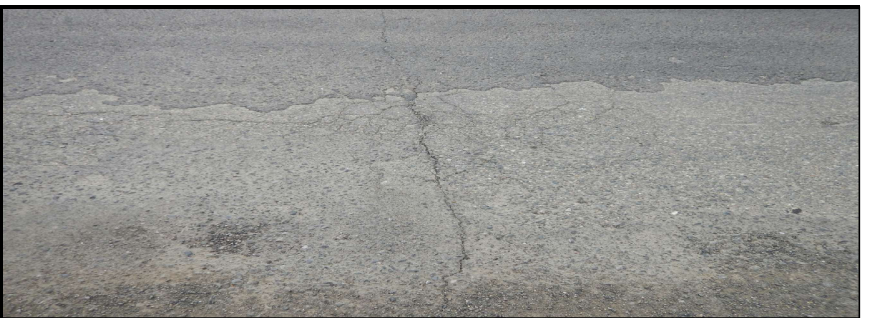
Photo #: Transverse and Map Cracking

Rutting in area of LT pattern cracking
 Wide full width crack over Pier 2
 Heavy pattern cracking in LT lane approx 200 sqft
 Approx 20 sqft of partial depth potholes.
 Thin patch over approx 50% of deck

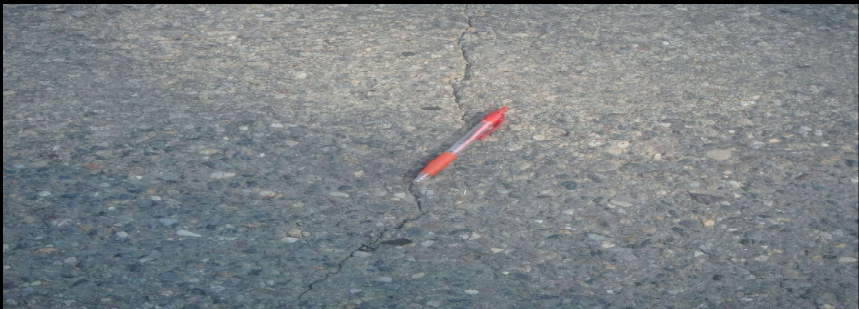
<p>Photo #: DECK CRACKING.</p> <p>Location:</p> <p>Comments:</p> <p>Element: 510 - Wearing Surfaces (SF)</p>

40 ft2 of potholes.
 7 ft2 of repaired areas.
 27 ft2 of CS3 cracking. See photo.

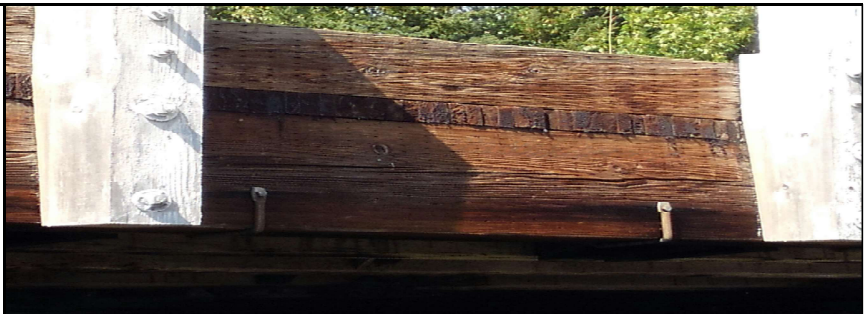
Element:111 - Timber Open Girder|Beam (LF)

Girder 4 has 6m of deep checks, a shake near midspan see photo. Also a shake a bearing area 1m in length. Girder 5 has a check full length on side. Girder 6 has check half length on side. Right exterior has deep weather checks. Condition State 1 : 70.05

Minor checking in many
 G1 - 9 ft CS2 check
 G4 - 6 ft check midspan, 2 ft long end shake
 G5 - Full length CS2 check - 28 ft
 G8 - 3 ft CS2 check
 G9 - 1 ft check from mechanical damage midspan
 G13 - 9 ft CS2 check
 G13 has 18 ft of deep checks. Photo

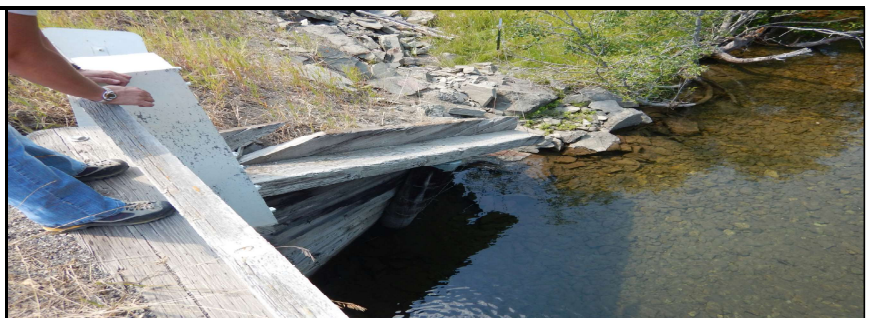
Photo #:Abut 1 LT Deflection

Abutment one left wingwall is deflected, column possibly broken but too deep to inspect. All four wingwalls and abutment deflected. Condition State 1 : 69.47
 Abutment one left wingwall is deflected, column possibly broken but too deep to inspect. All four wingwalls and abutment deflected. Condition State 3 : 10.53
 Abutment one left wingwall is deflected, column possibly broken but too deep to inspect. All four wingwalls and abutment deflected. Condition State 2 : 20

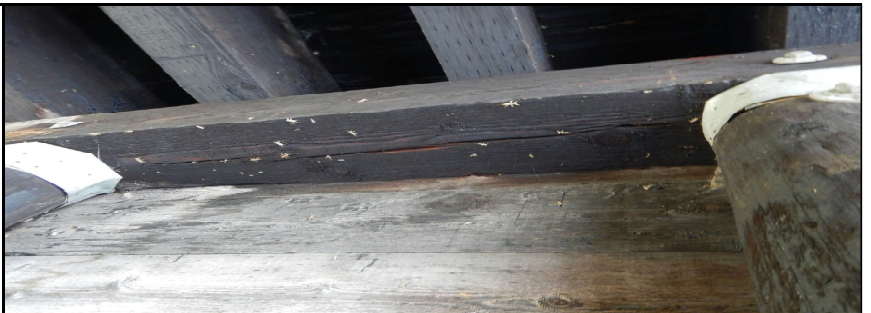
Element: 235 - Timber Cap (LF)

Abutment two has a deep check along lower surface and 3m check along rt exterior cap face. Condition State 1 : 50
 Abutment two has a deep check along lower surface and 3m check along rt exterior cap face. Condition State 2 : 50

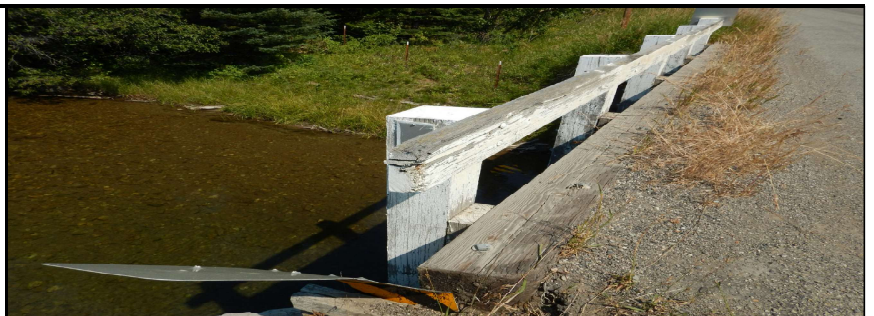
Element:332 - Timber Bridge Rail (LF)

Approx 1 ft of impact damage to Abut 2 end of RT rail
 CS2 checking throughout posts and rail
 6 ft of end splitting on RT rail
