Bridge Inspection Reports

STRUCTURE INSPECTION REPORT

Structure # 03808
 FLATHEAD CREEK 009 - NE WILLSALL

Bridge Inspection Date: 07/24/2018

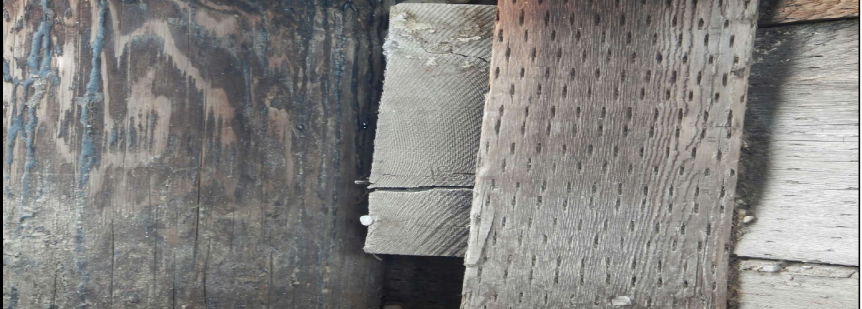
Minor scour along Abut 3 backwall and RT wingwall
 Exposure of roadway fill under backwall and erosion around wingwall. See photos in Element 900
 Multiple CS2 checks in all 4 wingwall pile.
 Random areas of CS2 checking in backwalls, wingwalls CS checks most of length
 Many end splits in backwall and wingwall planks - approx 8 ft
 Percent adjusted for defect overlap

Element #	Parent Element	Name	Unit	Quantity	%CS 1	%CS 2	%CS 3	%CS 4
Photo #: Typical End Splits Location: Comments: Element: 216 - Timber Abutment (LF)

Repair Suggestions:					
Repair ID	Date Requested	Type	Status	Priority	Comments
#Error	07-25-2018	Repair suggestion	Open	Low	Bank erosion at Abut 3 RT wingwall. Repair is suggested to preserve abutment in future high water events

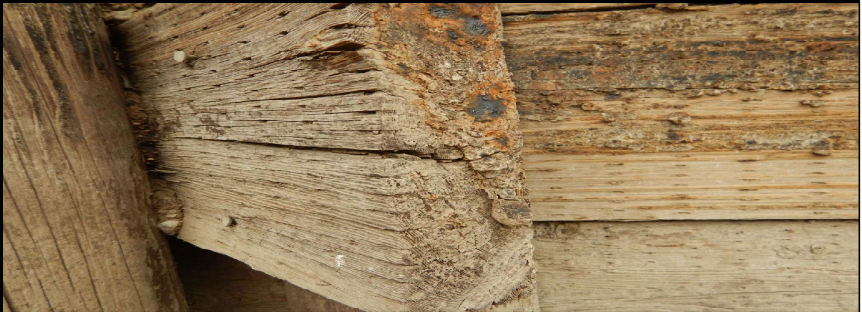
Photo #: Typical End Splits Location: Comments: Element: 216 - Timber Abutment (LF)

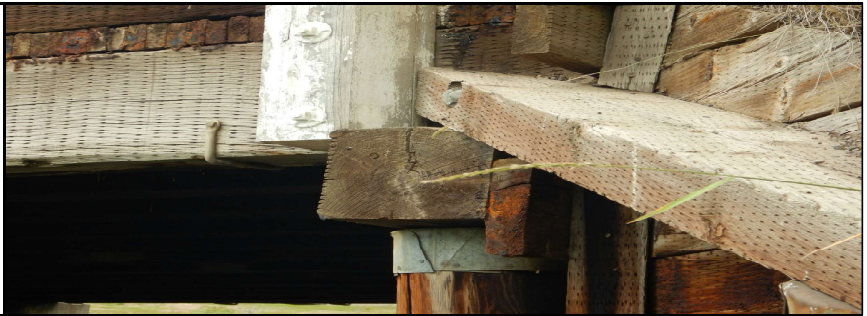
Photo #:Abut 1 Cap End Check

3ft deep of st3 checks on all 6 ends of timber caps. Condition State 3 : 24
 Good condition. Condition State 1 : 76

Element:235 - Timber Cap (LF)

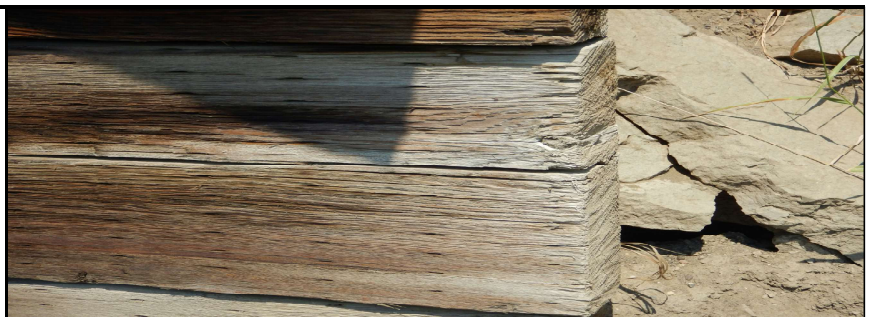
Element:216 - Timber Abutment (LF)

Photo #:Abut 1 LT Deflection
